CREATING A WORLD CLASS SAFETY CULTURE

LESSONS LEARNED FROM LAUNCH VEHICLE FAILURES

Stan Graves

NESC Academy Webcast

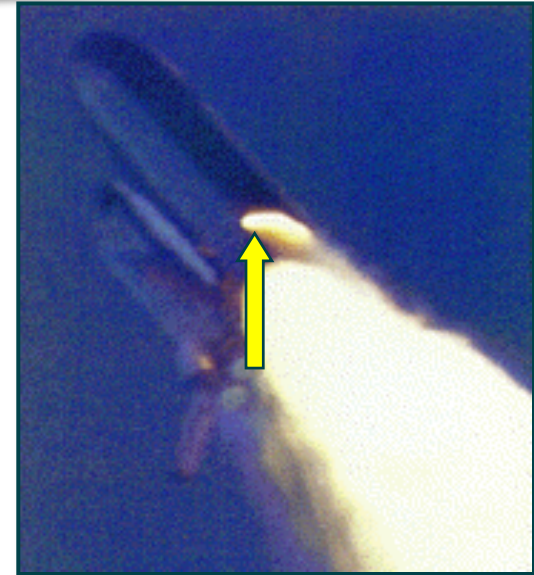
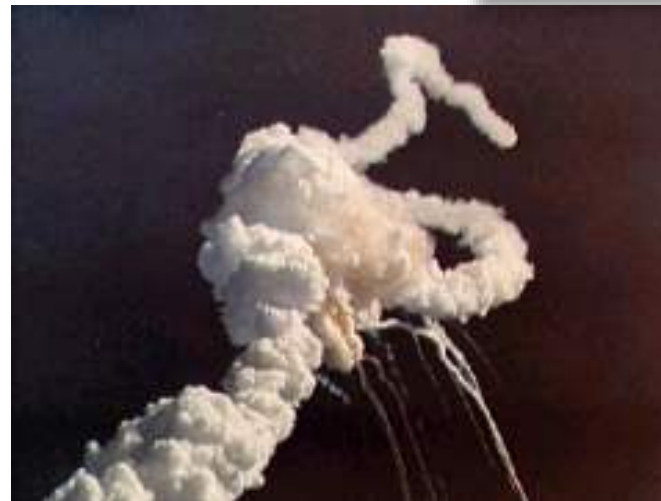
Leak at T + 0.678 Seconds

**MAXIMUM DYNAMIC
PRESSURE AND WIND SHEAR**

Joint Leak Restarts

T + 59 Seconds

Explosion

T + 76 Seconds

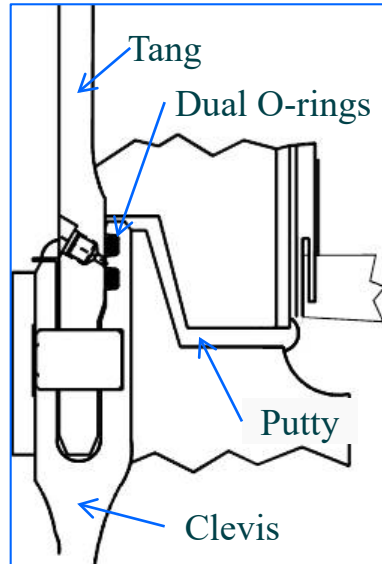
**Pressurized Joint:
Rotation Effect (exaggerated)**

*Early finite element models used nodal constraints to attach the tang to the clevis. Improper radial constraints made the joint appear static.

The **September 1977** hydrotest data showed the *field joints were rotating open to the point* where the O-rings could lose contact with the mating surfaces

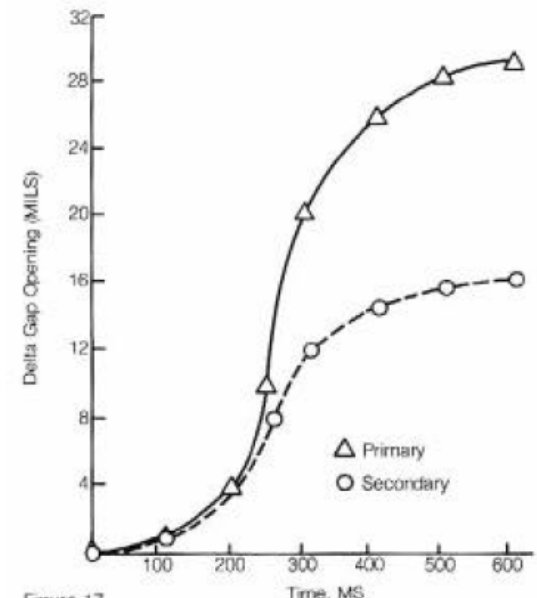
Right Hand SRM Aft Field Joint Primary And Secondary Delta Gap Opening

Figure 17
Graph plots changes in right booster's aft field joint primary and secondary gap openings. Horizontal scale is time in milliseconds from ignition.

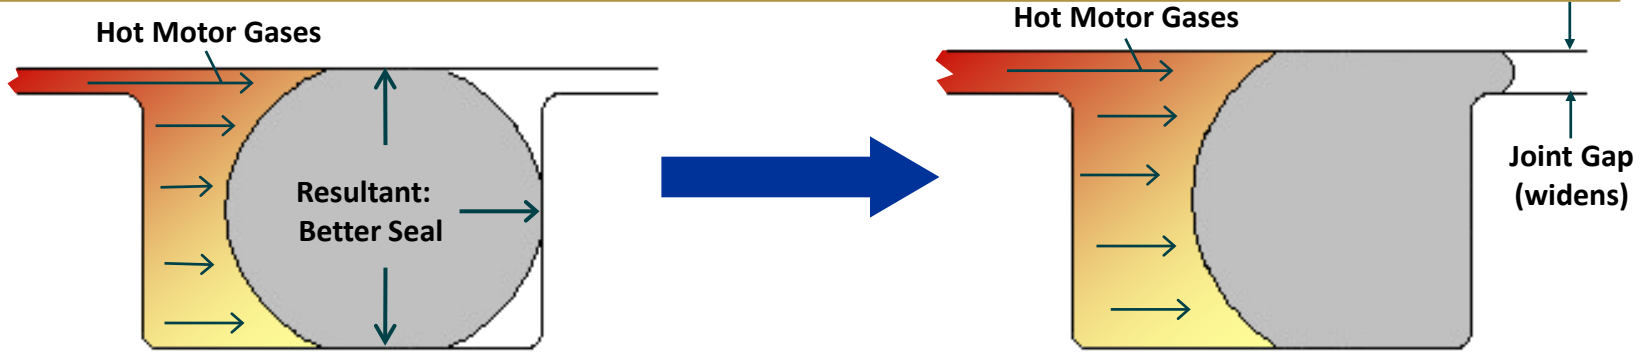
Prior to Challenger, it was believed that the secondary O-ring would be in a position to be forced into the extrusion gap via “pressure assist”

O-ring as Pressurization Begins: Desired Configuration

O-ring After Pressurization: No Blow-by

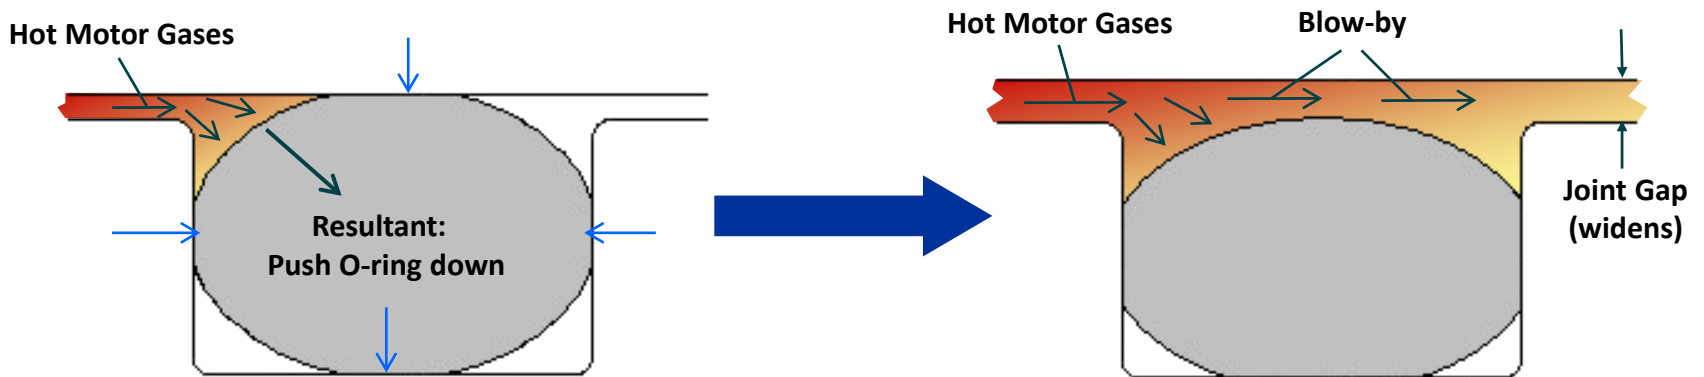
After Challenger, it was learned that design changes to create ever greater O-ring squeeze could result in “4-wall” contact resulting in potential blow-by of both the primary and secondary O-rings *at any temperature*

O-ring as Pressurization Begins: 4-wall Contact

O-ring After Pressurization: Blow-by Occurs

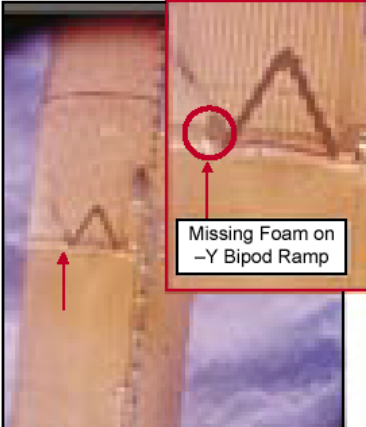
- Foam was lost on the STS-112/ET-115 –Y bipod ramp (≈4" X 5" X 12") exposing the bipod housing SLA closeout

The Mission Management Team wasn't concerned about the impact*.

“Like hitting a Styrofoam cooler with your car...”

Except, the car is going 550 miles per hour, and the chunk of foam weighs 1.7 pounds

*Why the Mission Management Team wasn't completely pucker'd by the foam impact on ignition is baffling to me. They knew the mass and velocity of the foam at impact. A simple kinetic energy calculation would show that the impact energy was 2 orders of magnitude higher than that required to damage the Orbiter carbon-carbon leading edge.

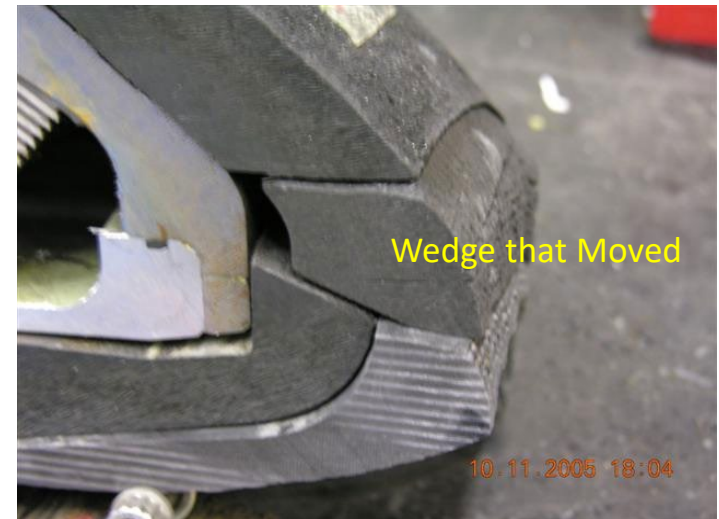
- Nozzle is not performing as designed, and technical understanding of phenomenon is not 100% solid

- Two static test nozzles worked, but performance did not meet design intent
- **Design Team** concluded that the risk of nozzle failure was low, and *recommended that the program proceed without modification*
- *After seeing the 7 Elements Risk Assessment, Management found the risk to be unacceptable*
 - The nozzle was successfully redesigned
