NASA/TM-2020-220573  
NESC-RP-12-00823

# Recurring Causes of Human Spaceflight Mishaps during Flight Tests and Early Operations

*Timothy S. Barth/NESC  
Langley Research Center, Hampton, Virginia*

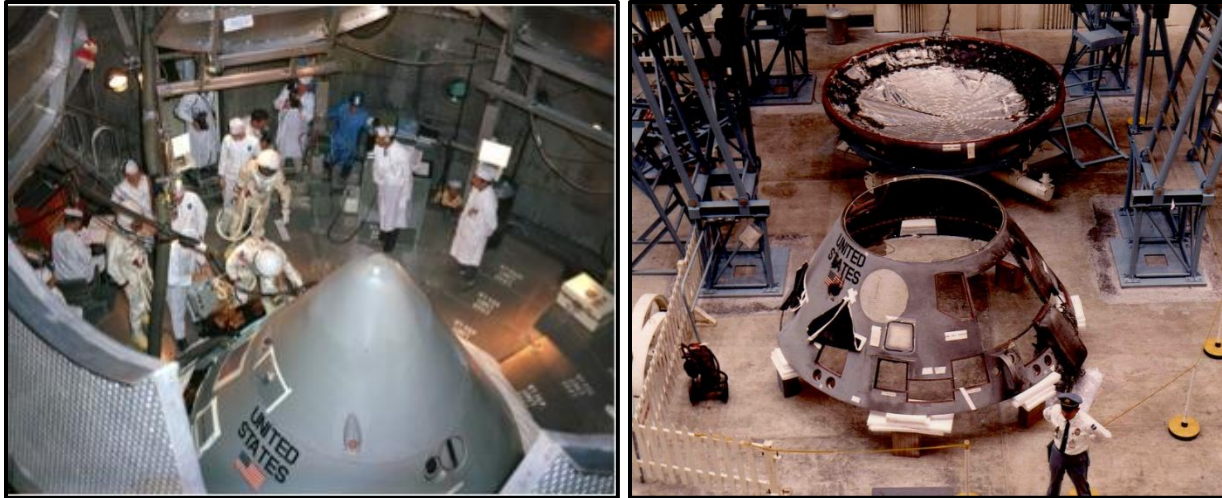
The fire that led to the loss of three astronauts on January 27, 1967, was probably caused by an electrical arc from a Teflon-coated wire near the floor of the capsule [ref. 6]. The delicate wire was powered by the main power bus. Post-mishap interviews revealed a notable amount of traffic capable of damaging wiring insulation. The choice of the insulating material (while it was a superior heat insulator) made it unusually susceptible to damage from friction. Since a decision was made to conduct Apollo operations in a 100% oxygen environment pressurized to 16.7 psi, as had been done in the Mercury and Gemini capsules, previous successes in those programs served to effectively conceal the risks of combustibles in the cabin. Images of the Apollo 1 command module before and after the tragedy are shown in Figure 7.1-1.

***Figure 7.1-1. Apollo 1 Command Module Fire at LC 34***

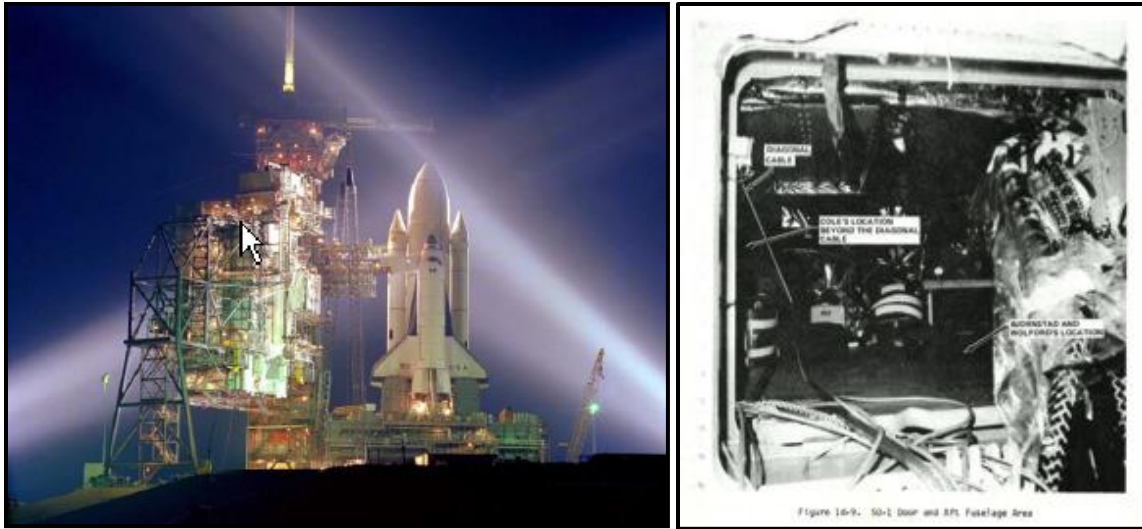
During a simulated countdown involving the flight crew at the launch pad on March 19, 1981, many tasks unrelated to the simulation were being worked around the orbiter. All the tasks were managed from the firing room, but deviations to the standard procedures had to be made to accommodate the concurrent activities. In fact, more than 500 deviations were authorized. One activity was a nitrogen purge in the orbiter aft section to perform a leak check. The activity was not labeled hazardous on the schedule, so there was minimal review by safety personnel. Figure 7.1-4 contains images of the STS-1 stack at LC 39A and the opening for the orbiter aft compartment access.

**Figure 7.1-4. STS-1 Stack at LC 39A (left) and Orbiter Aft Access Opening (right)**

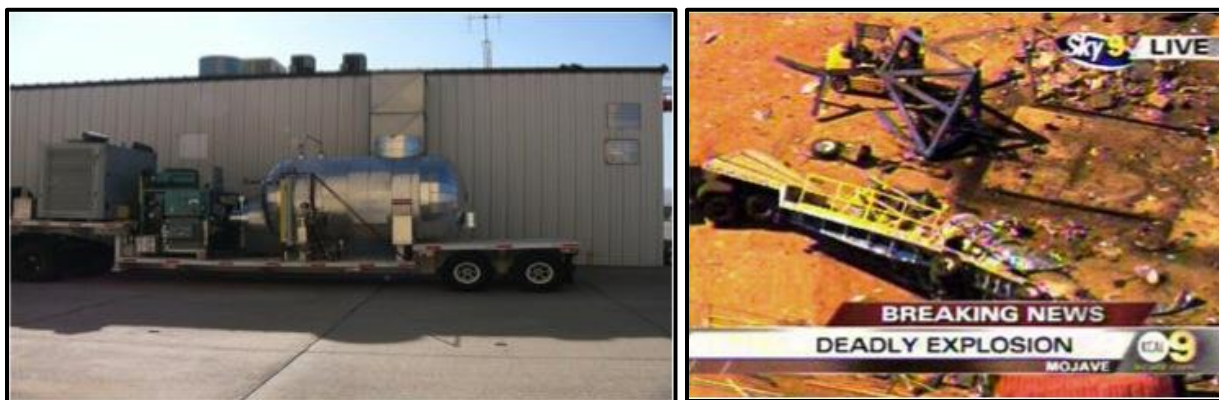
Ground operations for SpaceShipOne included testing a steel tank carrying approximately 10,000 lb of N<sub>2</sub>O (see Figure 7.1-6). While testing in the desert at approximately 105 °F on July 26, 2007, the N<sub>2</sub>O tank exploded, killing three ground crew members and injuring three others. The ground crew was reportedly unaware that N<sub>2</sub>O above 96.8 °F becomes a supercritical fluid and is much easier to ignite than in its gaseous state. Furthermore, the N<sub>2</sub>O was being transferred to a composite tank. N<sub>2</sub>O decomposes most composite materials and produces a vapor that is also explosive [ref. 29].

*Figure 7.1-6. Steel N<sub>2</sub>O Storage Tank (left) and Explosion Site (right)*
