Lesson 10: Selected Apollo & Shuttle Lessons Learned (Part 2)

- Identify additional pressure vessel failures (not covered in Part 1) from Apollo era & lessons learned
- Identify 2 Shuttle program thermal protection system (TPS) failures & lessons learned

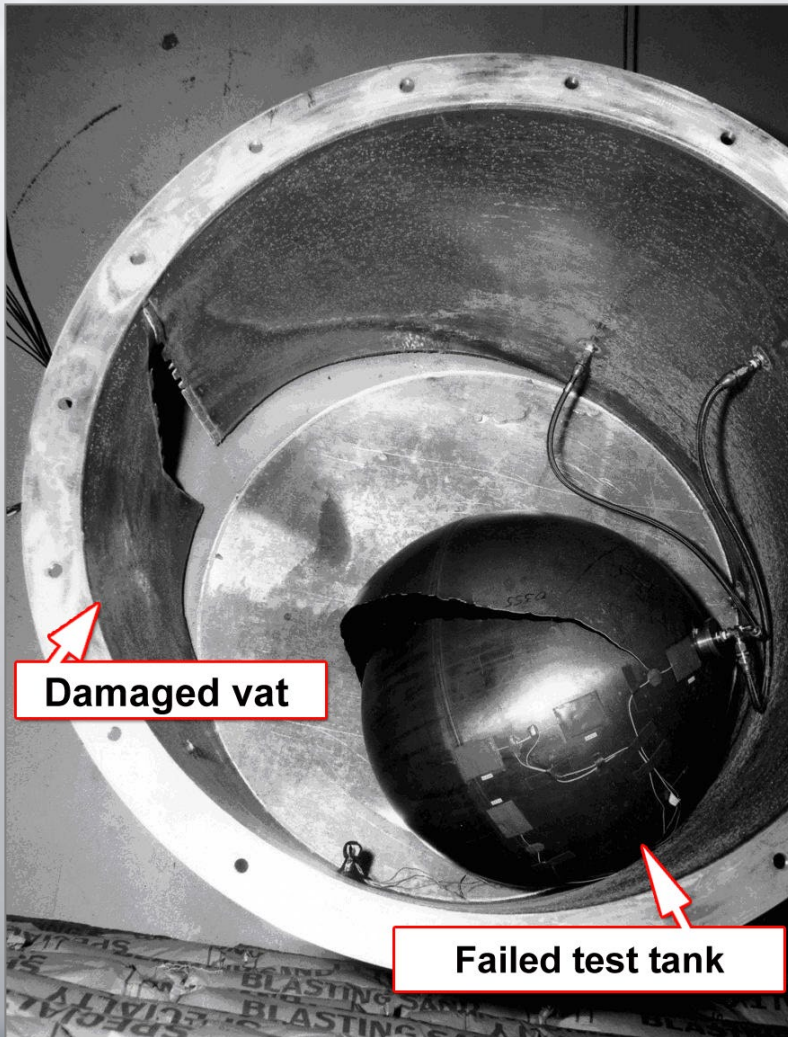
1st ARDE Stainless Steel Tank Failure

- Failure during volumetric expansion test
 - Proof pressure was 1,337 psi
 - Tank exploded unexpectedly at 1,160 psi

- New tank material
- First stainless steel tank was filled with water
- Tank immersed in protective aluminum vat, also filled with water
- Bottom of tank touched inside of vat
- Contact created galvanic cell
- Started localized corrosion process
- Released hydrogen
- Cryoformed 301 CRES sensitive to hydrogen

- Barrier placed inside vat
- Tank placed on nonconductive pad
- No contact between vat & tank
- No galvanic cell
- Damage mode eliminated

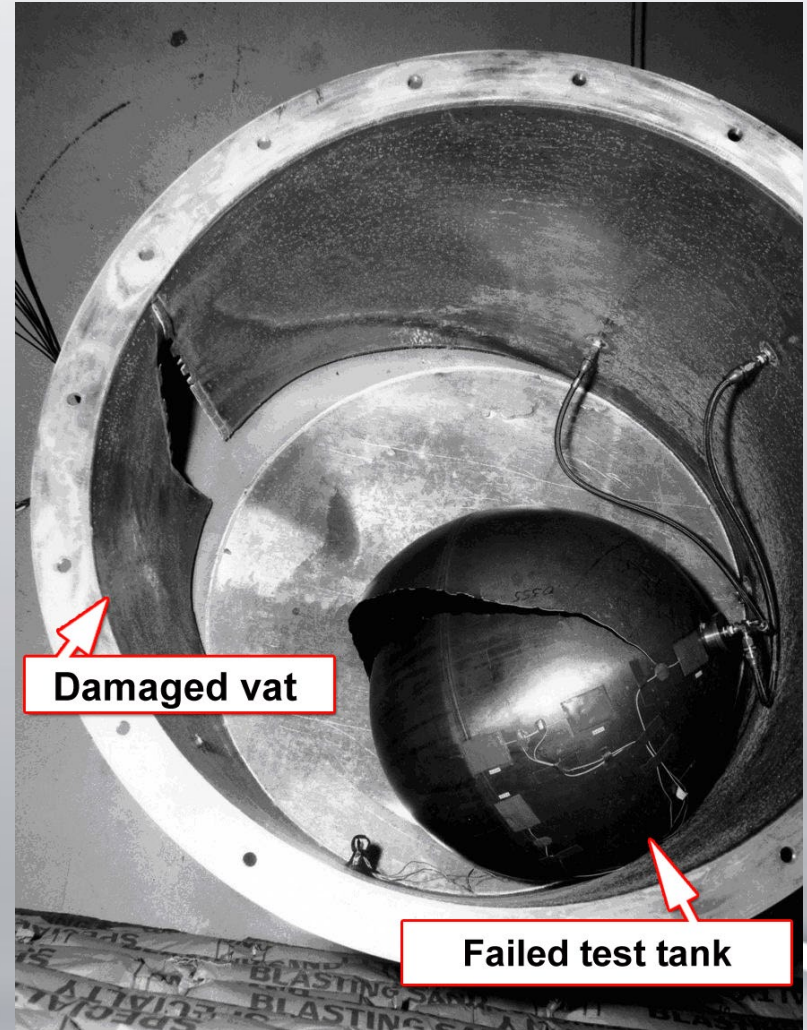
2nd ARDE Tank Failure

- Tank exploded during a pressure hold at 1,337 psi
- Tank immersed in water with galvanic barrier during test
- Strain gages applied to tank prior to hold test & then waterproofed
- Waterproof coating attacked cryoformed steel when strain gages applied, causing localized cracking
- Stress corrosion proceeded at tips of induced cracking, growing until critical flaw size (onset of unstable crack growth fracture) was reached

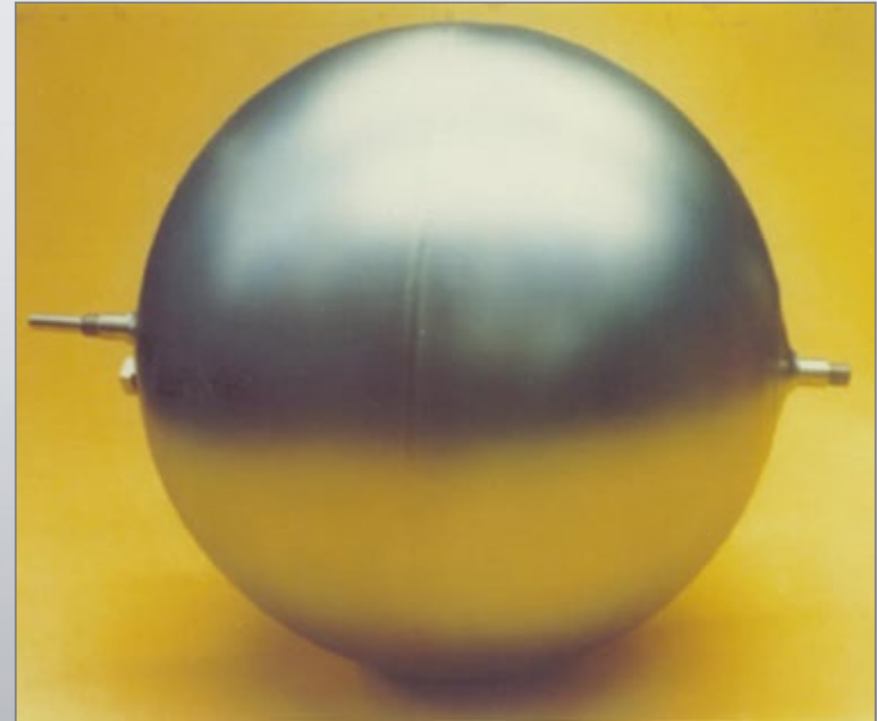
Cryoformed stainless steel tank

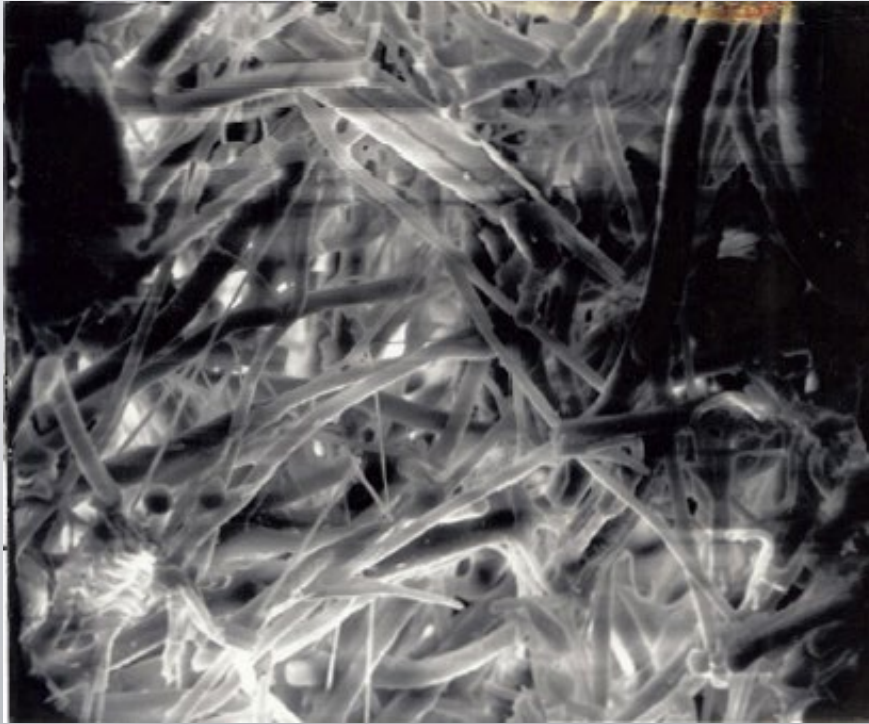
Tile system structure

- TPS protects Space Shuttle from:
 - Heat during reentry
 - Hazards of space
- TPS tiles are blocks of fibrous silica
 - Soft porous structure
 - Not strong structure

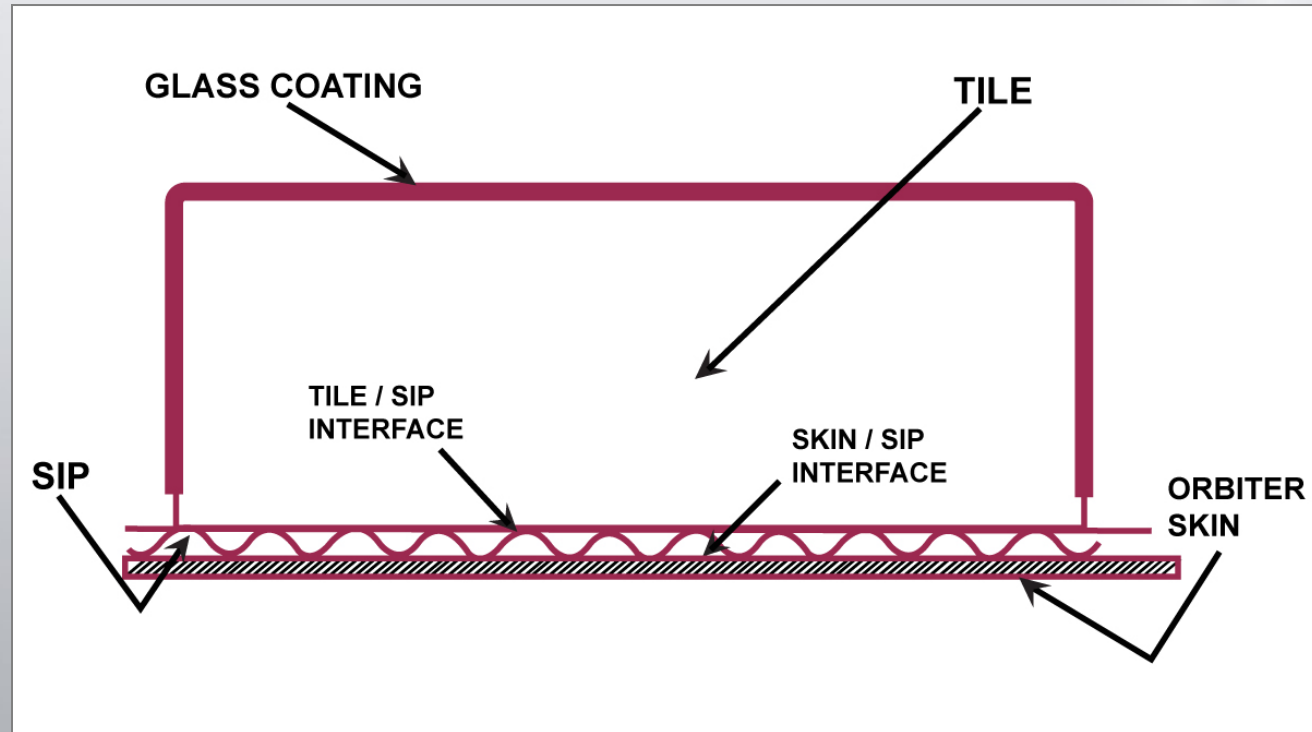
Orbiter Tiles Fall Off During 1st 747 Aircraft Ferry Flight

- May 1979—
Several tiles fell off Orbiter when it was ferried by 747 aircraft to Kennedy Space Center
- Tiles vital to protection of Orbiter during reentry

- Tiles were glued to Orbiter skin with room-temperature vulcanizing (RTV) silicon adhesive & Nomex strain isolation pad (SIP)
 - SIP “needling” caused localized stress concentrations along bondline interface with tiles
 - Concentrations resulted in low bond strength
- Original tests of bond strength conducted on small (2"×2") flatwise tensile specimens, not full-sized tiles
- Dynamic testing had not been started

- Massive proof testing effort
 - Conduct acoustic emission test on each tile
 - Replace any tiles that come off
 - Test took 3 hrs/tile
 - Space Shuttle has ~6,000 tiles
- Testing not reliable enough or fast enough—stopped before complete

- Densification of tile's bottom surface:
 - Eliminated voids
 - Exposed denser, stronger surface to RTV at bond
 - Allowed stress concentrations to be “neutralized” & not a performance factor
- 2 densification methods developed:
 - LUDOX process, which added silica to tile surface
 - Tetraethylorthosilicate (TEOS) process, which also added silica to tile surface

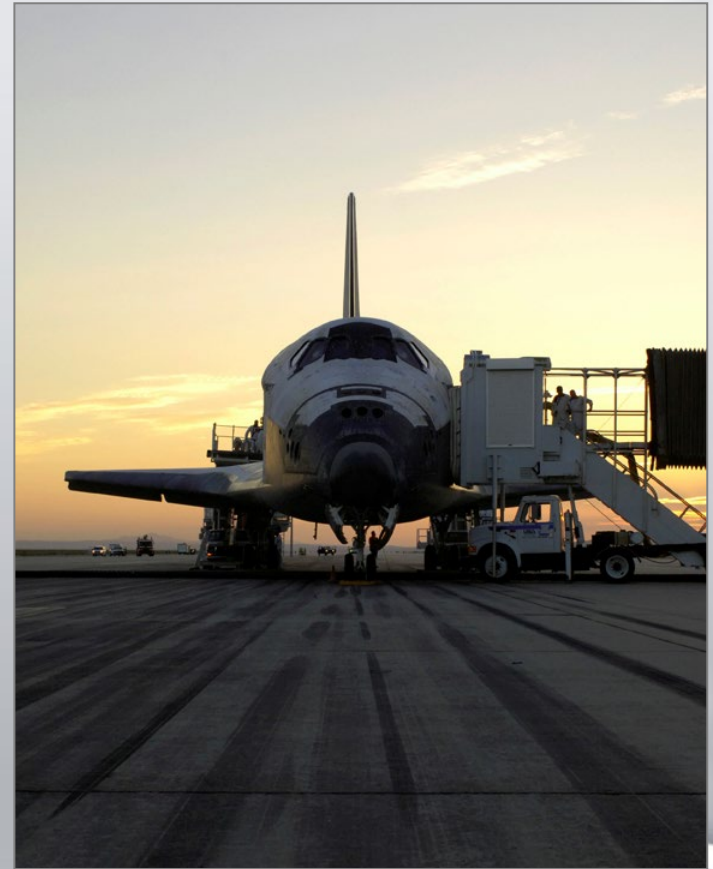
Tile Coating Repairs Fail During Vibration Testing

- TPS tiles coated with thin film of borosilicate glass
- Coating prevents tiles from absorbing water
- Coating easily damaged
- Initial repair method only certified for thermal environments

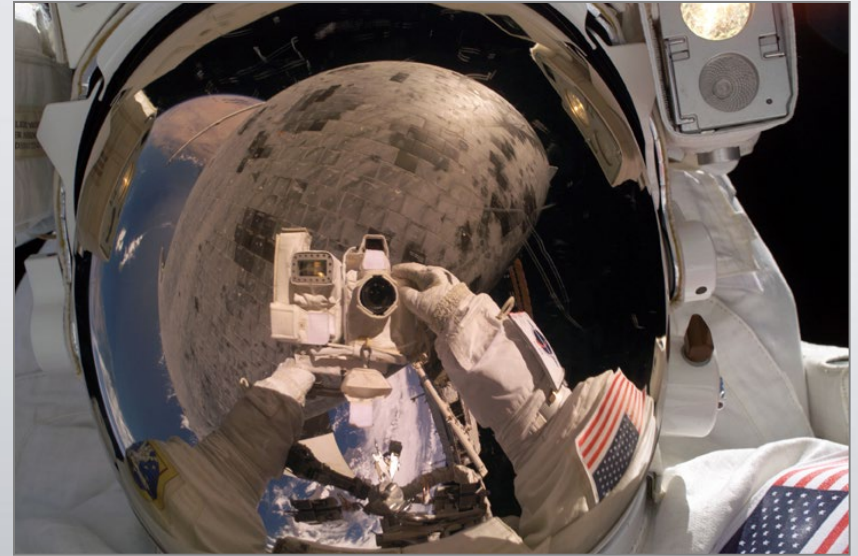
- Installation of tiles preceded completion of dynamic TPS testing
- Repair method not certified for dynamic performance
- During vibration testing, many tile surface repairs fell out
- Launch vibration might cause loss of tile repairs needed for reentry protection

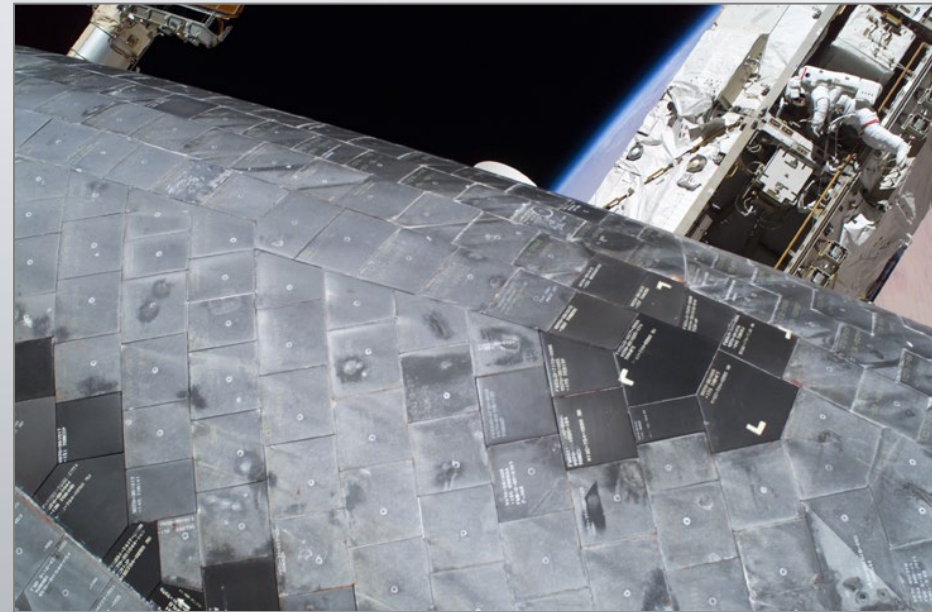
- Tile material very soft & lightweight
- Repair material very hard & heavy
- During dynamic movement, hard repair material damaged surrounding soft tile material
- Repair popped out
