# STS-124 Glove TMG Protective Patches

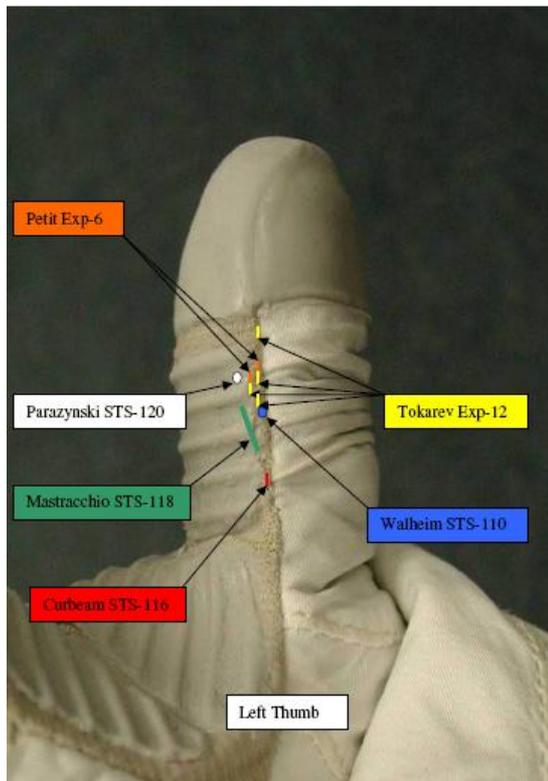
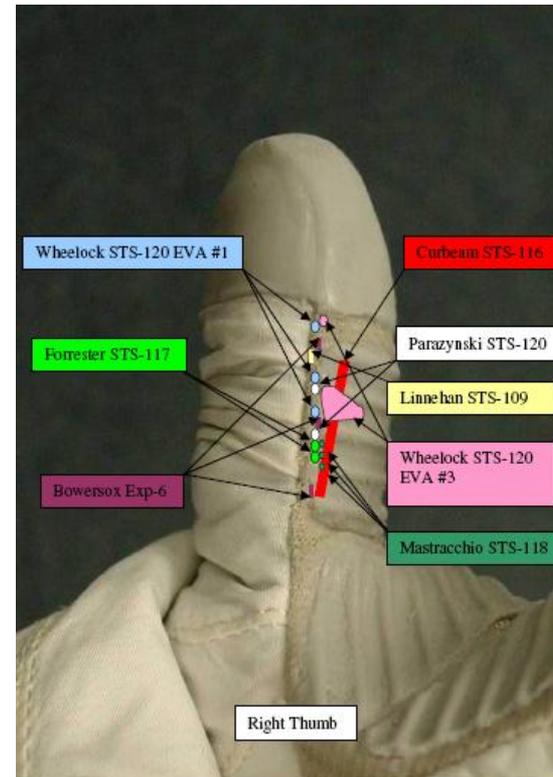
- Since STS-116 there have been several instances of glove TMG damage while EVA
  - Subsequent to STS-116 all available flight gloves were inspected for damage

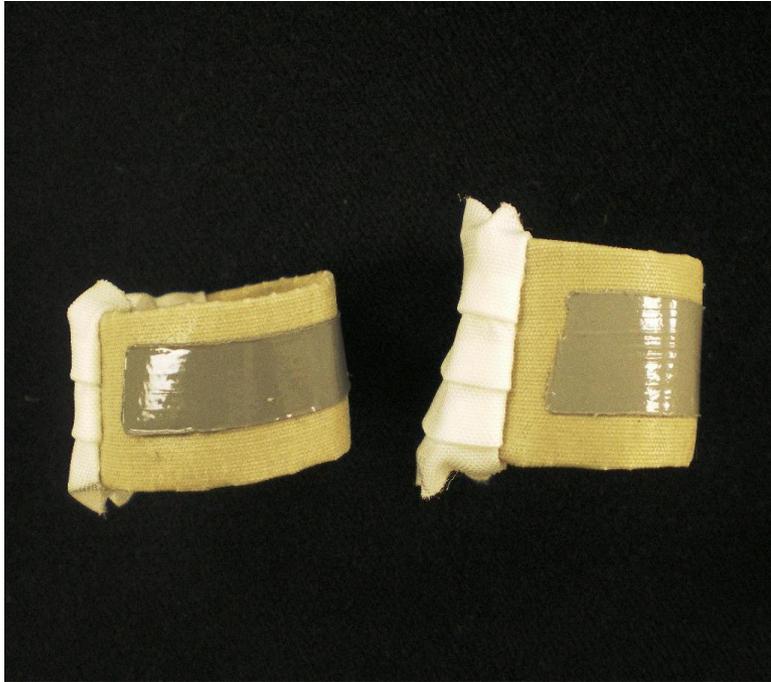
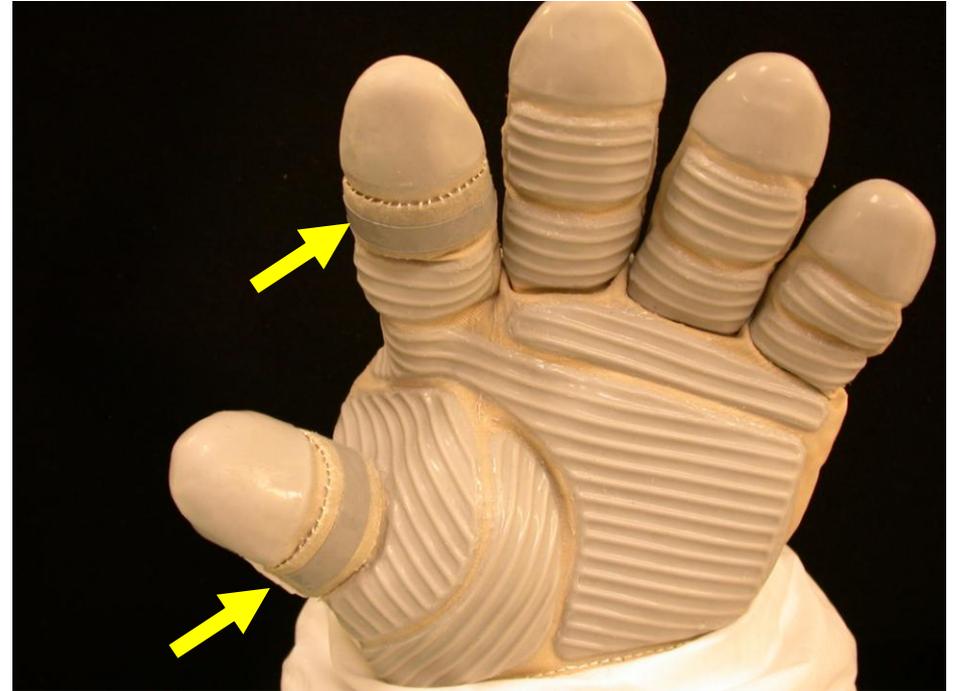
- The patch consists of TurtleSkin® fabric wash-coated with RTV 3145, a Teflon pleated back, and an additional strip of RTV 3145
  - Two to four times more cut resistant than the Phase VI glove knit Vectran
  - Higher puncture resistance than the Phase VI glove knit Vectran

- The Turtleskin® patch was developed as an alternative to the Overglove
  - Designed to harden the glove against sharp edge exposure
- Turtleskin® is a tightly woven Vectran that has a significantly higher cut and puncture resistance than the knit Vectran currently used in the glove palm
- The Turtleskin® patch is a field retrofittable modification that is sewn over the existing RTV pad
- Individual patches will be installed on the prime gloves in the areas of concern (i.e. the thumb and index finger)

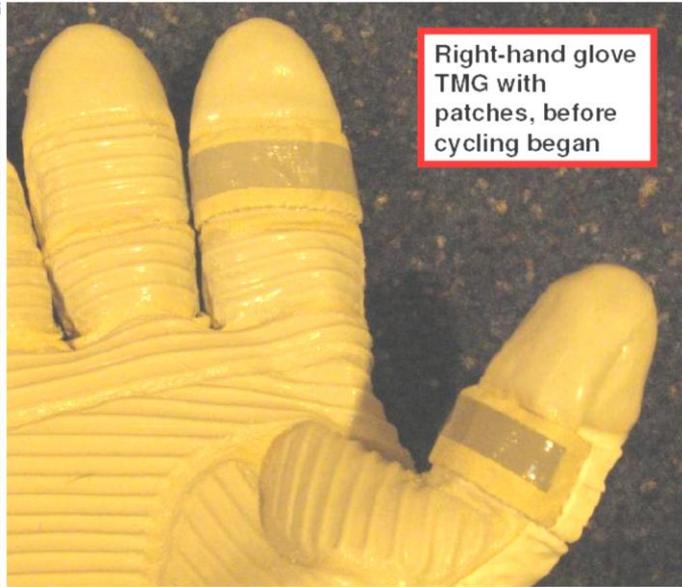
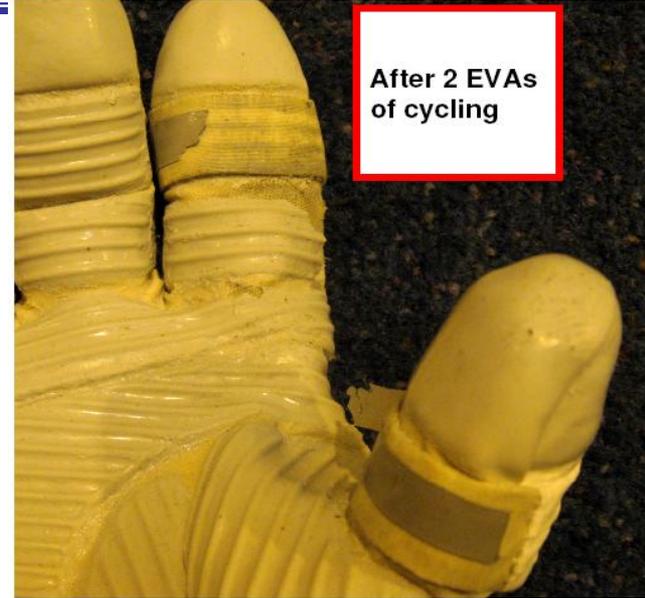
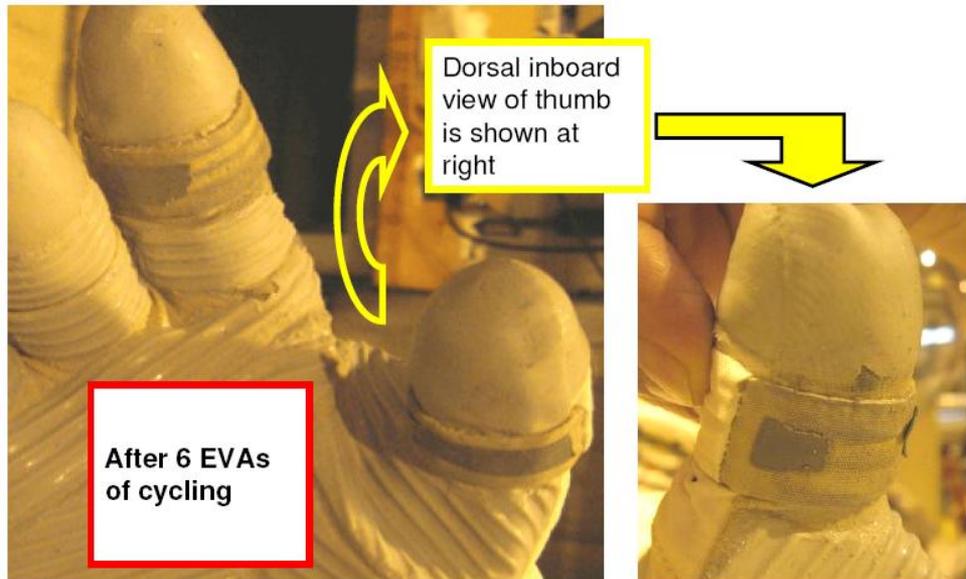
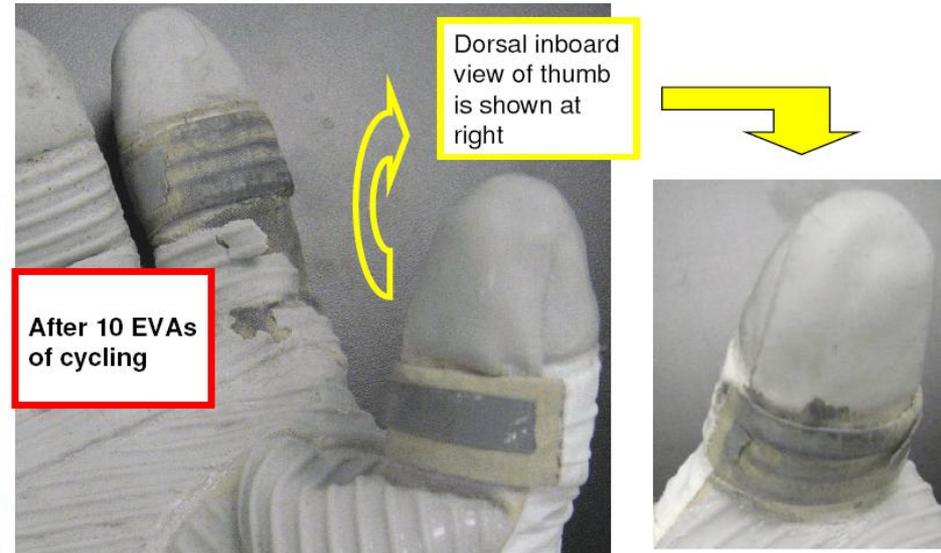
# Confidence Cycling Results

- A pair of flight configuration patched glove TMGs were subjected to ten simulated EVAs at ILC Dover
- RTV loss occurred as expected, but overall glove TMG integrity remained intact
  - RTV loss is a known condition and occurs mainly due to the forces involved in hand contact with various surfaces
- Throughout the cycling tests, patches remained in place as stitched, with no damage to attachment stitches
- TurtleSkin® endured the tests with no damage and exhibited remarkable tenacity as expected

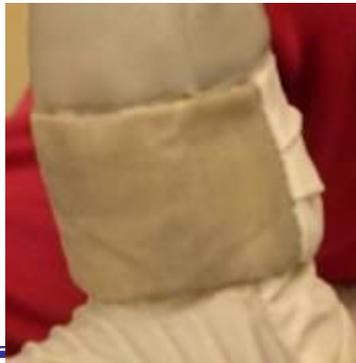
Initial Patch Design

- Glove box evaluations conducted to gain crew concurrence prior to retrofitting STS-124 and Increment 17 crewmembers training gloves with initial patch design
- NBL evaluations concluded that the design was acceptable for flight with the addition of some minor modifications:
  - Crew and engineering requested the addition of a thin RTV strip to the top of the patch to increase grip.
  - Crew also requested that the patch be made slightly smaller in order to decrease contact between the patch and the lower RTV pad.
- Successful glove box evaluations were conducted to evaluate the modifications
- Crew and engineering comments were incorporated into the final design

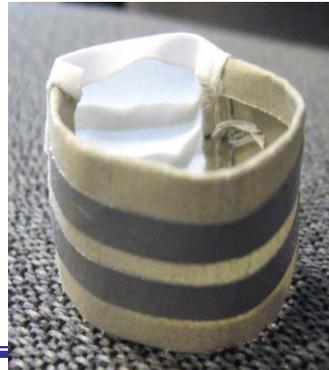
Interim Patch Design

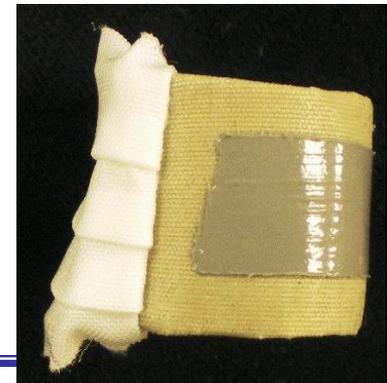
Flight Patch Design

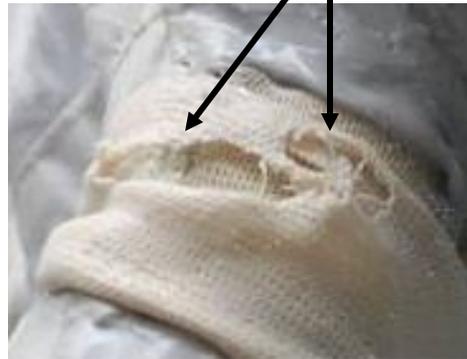
Vectran Damage ~3/4"

Phase VI Glove Vectran damage from simulated MMOD

- Cuts were induced on Knit Vectran after a single exposure
    - Subject was not able to cut the Vectran with slow high force gripping motions
    - Subject cut Vectran using a quick sliding motion across the MMOD impact site while pushing into the handrail

- TurtleSkin® Patch Results:
  - Attempted to cut the TurtleSkin® using the same motion that cut the knit Vectran
    - One attempt broke off a large burr that caused a  $\frac{3}{4}$ " cut in the knit Vectran

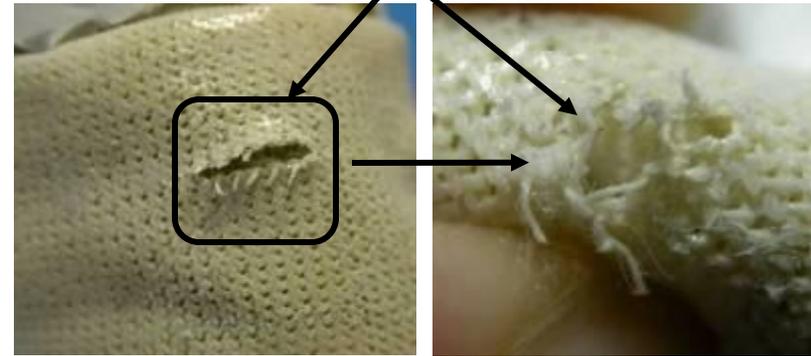
Vectran Damage ~1/4"

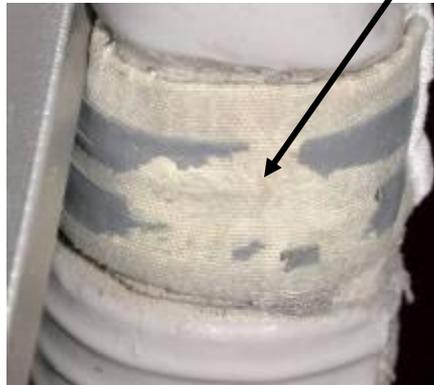
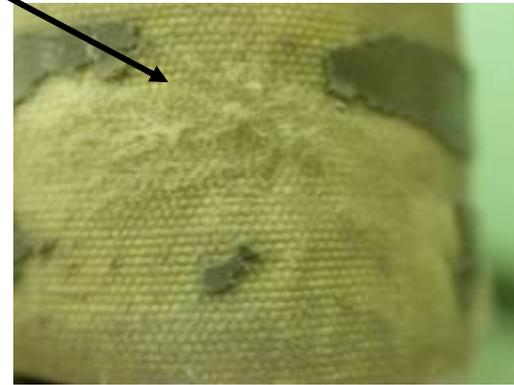
Abrasion

TurtleSkin® Patch after cycling on simulated MMOD

- No damage beyond surface abrasion and RTV loss (after 10 attempts on each glove)
  - Continued to cycle the same area of the TurtleSkin® against MMOD hits

- The left thumb patch showed only abrasion damage and RTV loss after 50 cycles
    - After 50 cycles an abrasion hole was created on the right thumb patch

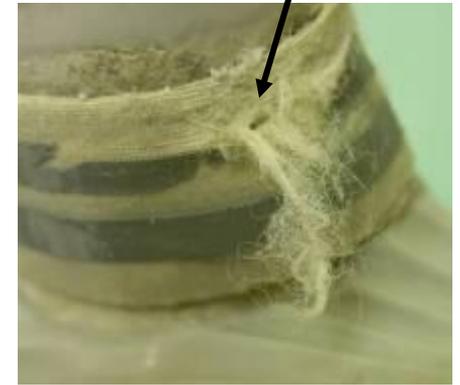
Abrasion Hole ~1/8"

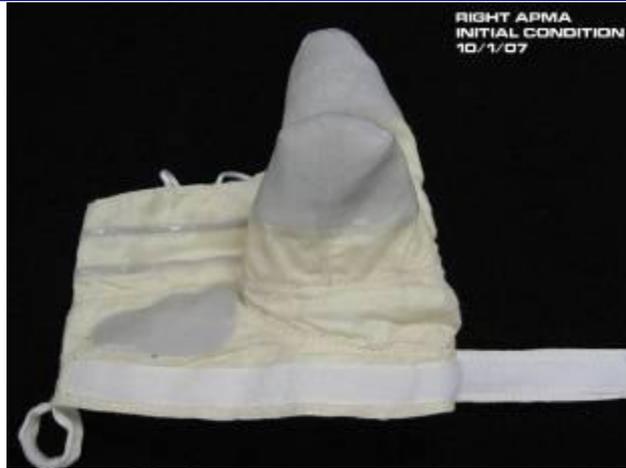
STS-120  
Overglove first flight

- In order to mitigate the risk, the EVA community has implemented several different measures:
  - STS-120/10A, Overglove first flight; Glove inspections
  - STS-122/1E, Implemented RTV loss criteria, Redesigned Overglove
    - Reduced excess material in the thumb and index finger
    - Implemented a second smaller size Overglove
  - STS-124/1J, Glove TMG protective patches first flight

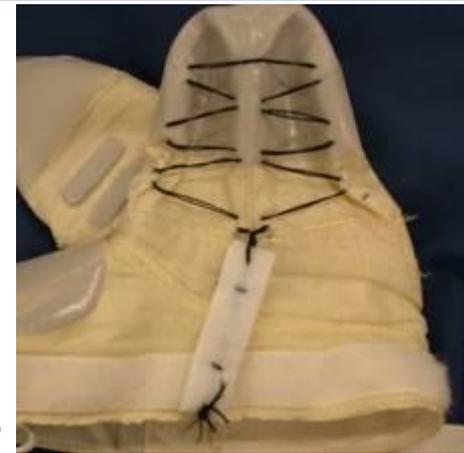
Increment 16  
On-orbit modification to Overglove

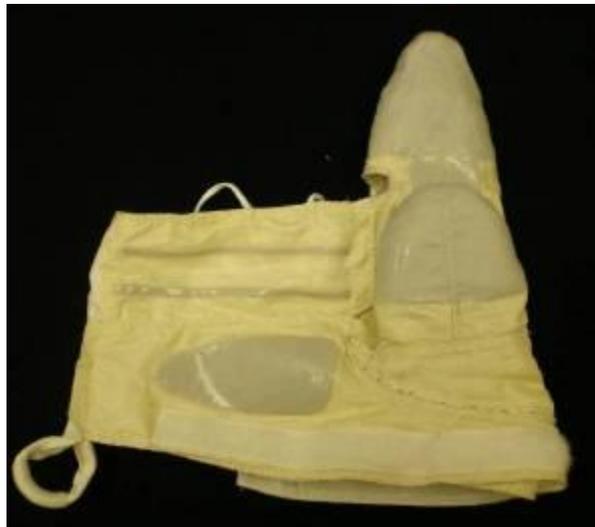
STS-122  
Redesigned Overglove

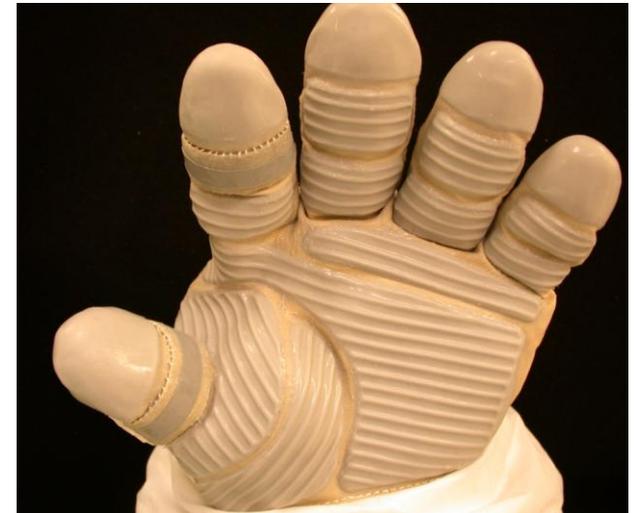
STS-124  
Glove TMG protective patches first flight
