CREATING A WORLD CLASS SAFETY CULTURE

LESSONS LEARNED FROM LAUNCH VEHICLE FAILURES

Stan Graves

NESC Academy Webcast

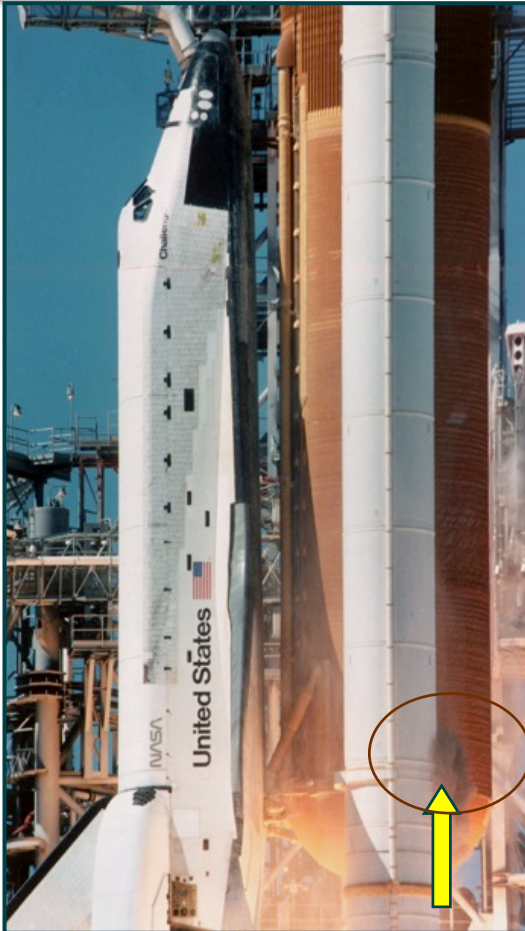
January 28, 1986 - Challenger Liftoff 11:38 a.m.

Leak at T + 0.678 Seconds

Joint Leak Restarts

T + 76 Seconds

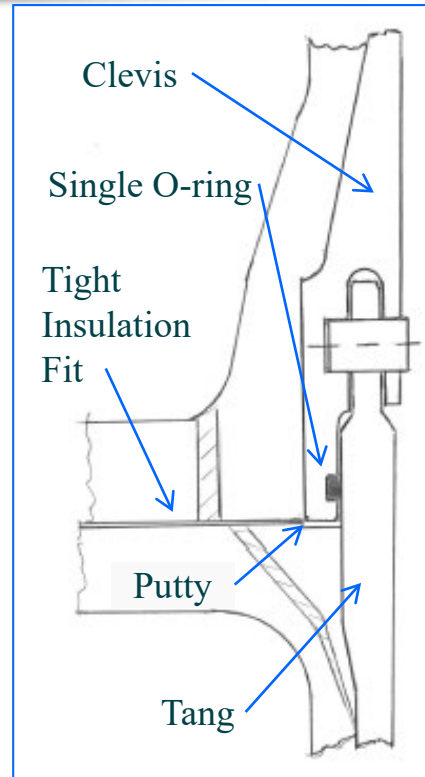
Space Shuttle SRM clevis field joint design based on successful Titan IIC design, circa 1972

In October 1977, NASA expressed serious concerns **that the field joint did not meet the design intent** (dynamic sealing versus static sealing), and **recommended a redesign**

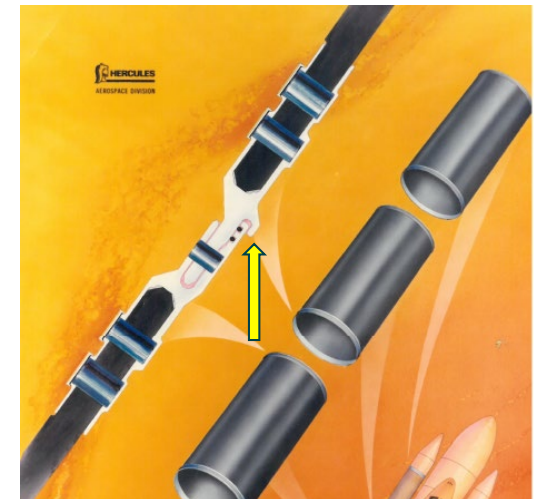
May 1982: NASA starts development program for a graphite/epoxy Filament Wound Case (FWC)

- Higher performance motors needed for DoD missions requiring polar orbits out of Vandenberg
- Design includes a “capture feature” to limit joint rotation

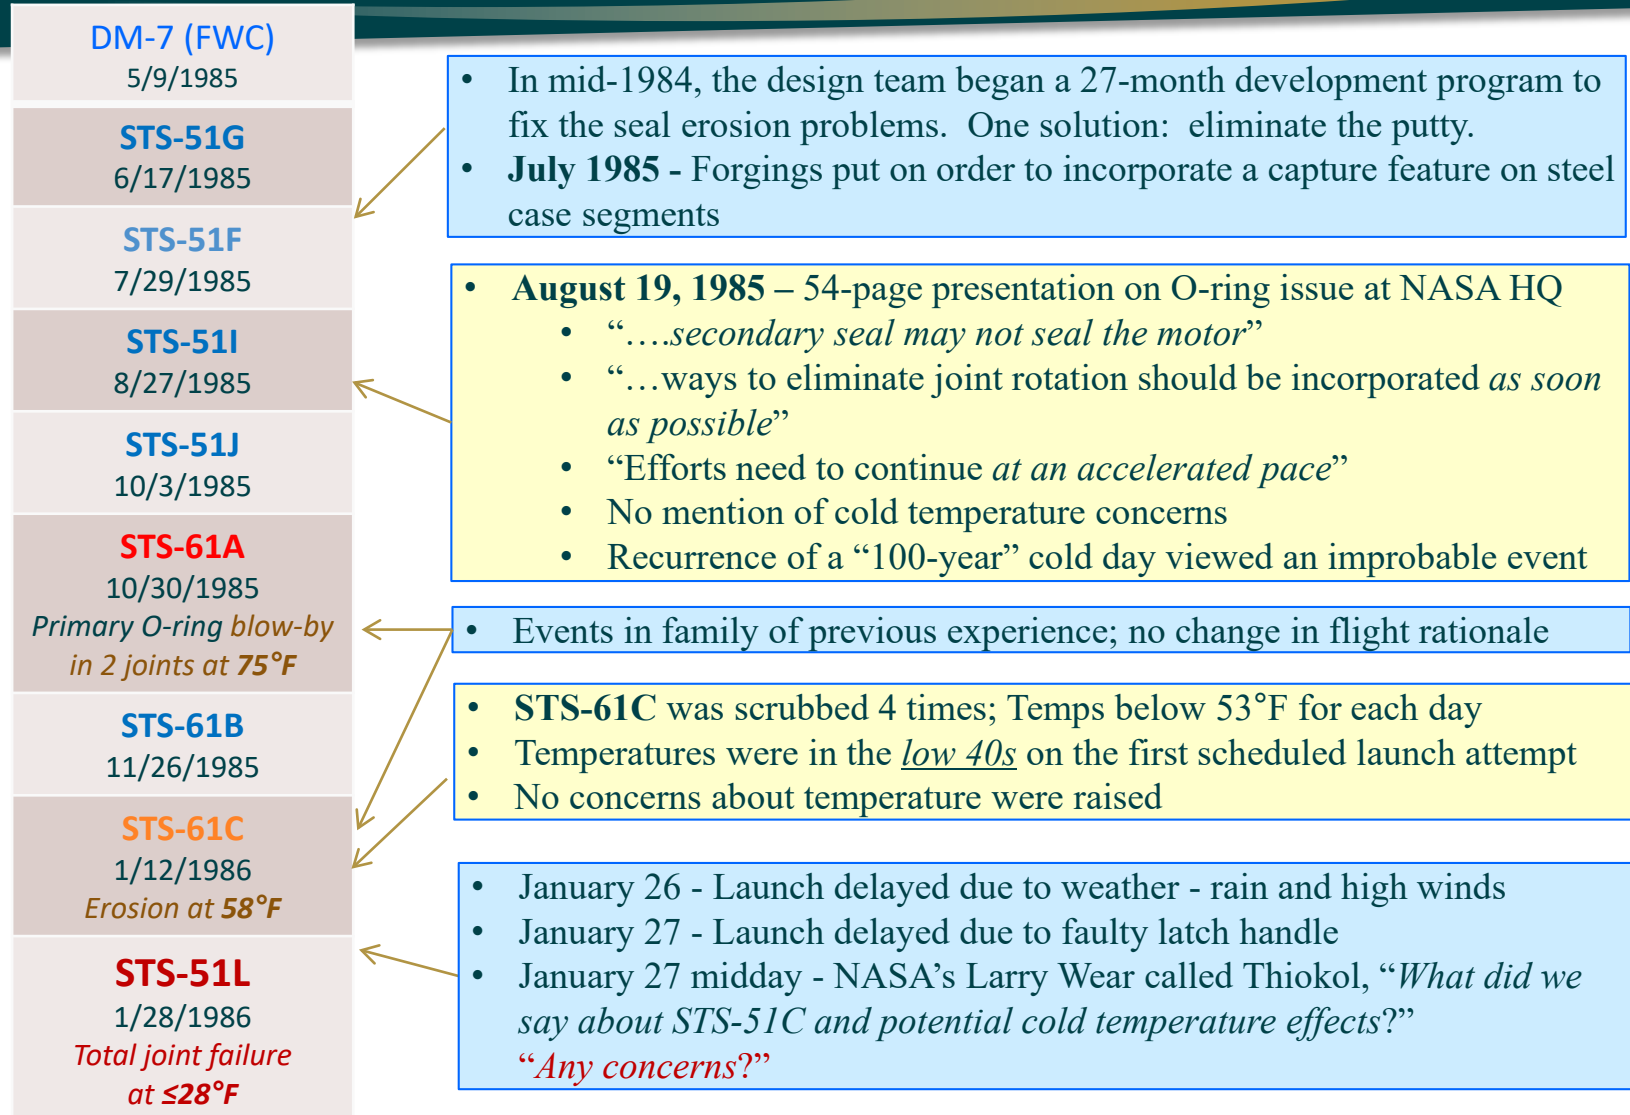
June 1985 - January 1986

Note that each time the hardware performance got worse, it was accepted and became the new basis for “in-family”. Diane Vaughn called this “Normalization of Deviance”.

- Flight rationale
 - Cold temperature effects: putty becomes stiffer, O-ring becomes harder, O-ring squeeze reduced
 - Low temperature enhances probability (STS-51C coldest in history)
 - Erosion within experience base and within established margins
 - Secondary seal in proper position via leak check
 - Secondary O-ring is redundant
 - STS-51D could exhibit the same behavior.
 - Condition is not desirable, but is acceptable

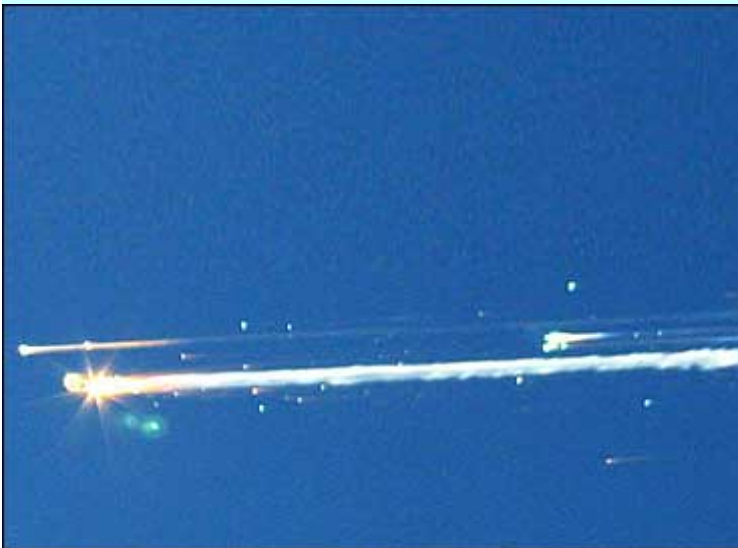
Columbia – 1 February 2003

Columbia Disaster: Bipod Ramp Foam Loss

*Why the Mission Management Team wasn't completely pucker'd by the foam impact on ignition is baffling to me. They knew the mass and velocity of the foam at impact. A simple kinetic energy calculation would show that the impact energy was 2 orders of magnitude higher than that required to damage the Orbiter carbon-carbon leading edge.

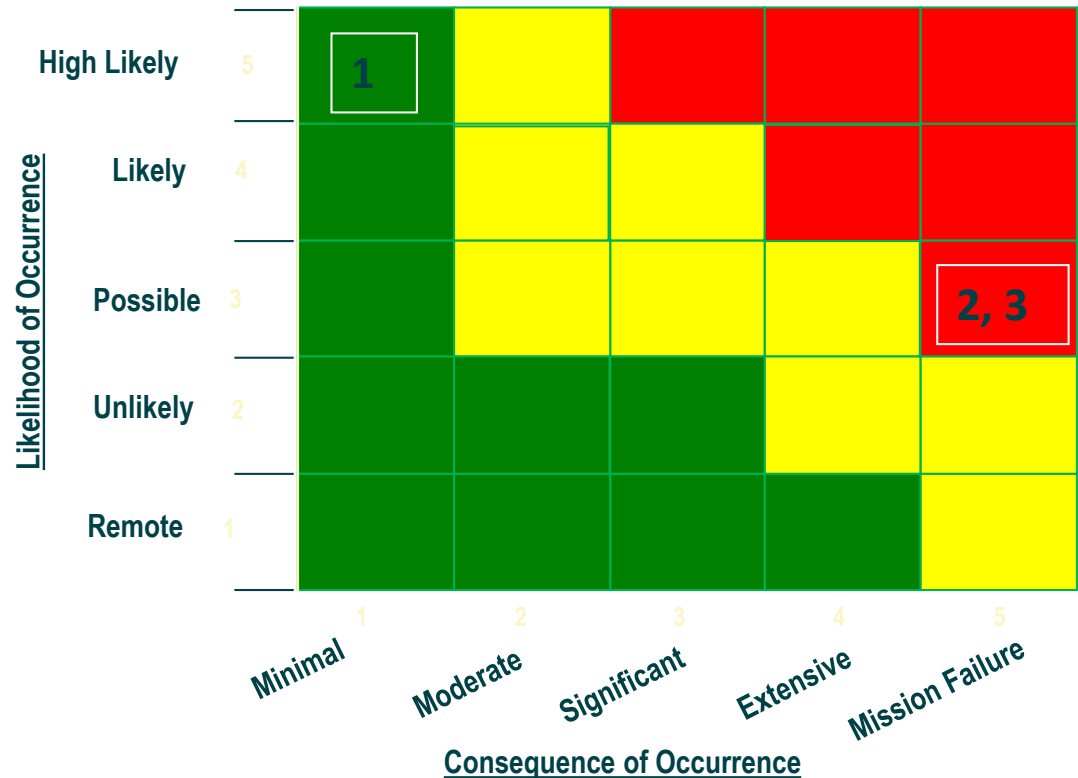
Nozzle Wedge Recommendation to Management

1. Nozzle experiences minor wedge-out
 - Performance similar to SFT-1 and SFT-2
 - **No impact on motor ballistic performance**
2. Delaminations propagate full circumference within a single ply
 - Entire wedge is ejected
 - **Nozzle is destroyed**
3. Small (7 mil) gap between rings allows hot gas flow to the metal housing
 - **Nozzle is destroyed**

- **Probability of nozzle failure is judged to be low**
 - The FT-2 nozzle is enveloped by the SFT-1 and SFT-2 results and any wedge creation is expected to be less severe than previously experienced
 - Expect no effect on ballistic performance
- **Nozzle failure is possible**
- **Failure risk can be mitigated by removing the current nozzle and replacing it with rayon based ablative rings**

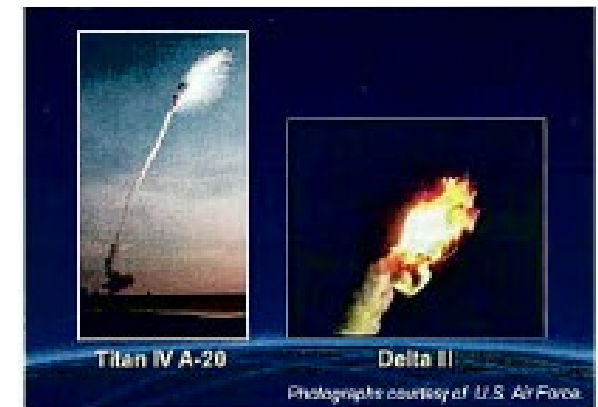
Figure 3. An unforgiving business:
“one strike and you’re out.”

Delta III 269 (May 4, 1999)

- Second burn of second stage lasted only 1 second placing satellite in wrong orbit

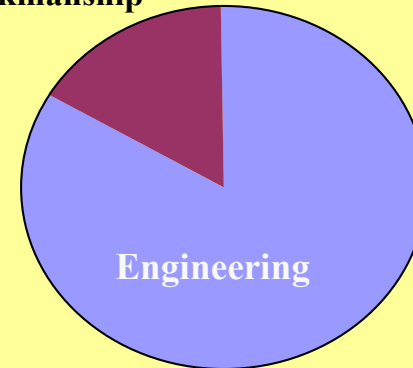
Causes of 13 launch vehicle failures (1985 – 1999)

Failures -- 76% Engineering Caused
