NASA/TM-2020-220573  
NESC-RP-12-00823

# Recurring Causes of Human Spaceflight Mishaps during Flight Tests and Early Operations

*Timothy S. Barth/NESC  
Langley Research Center, Hampton, Virginia*

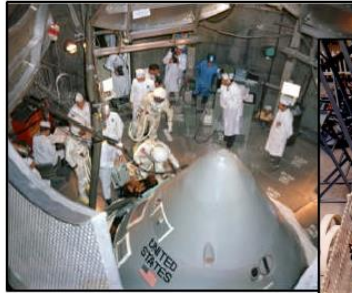
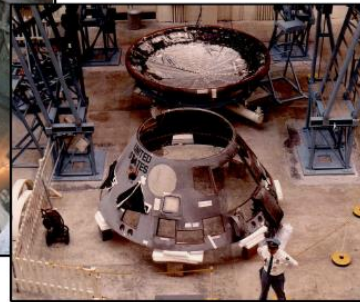
### Apollo-1 Crew Module Fire at Launch Complex 34

January 27, 1967  
Loss of Flight Crew (3)

- 40% of occurrences were related to inadequate system trade-offs or analyses of material selections
- **HSF-1 examples:**
  - *Apollo-1: Teflon wire coating was chosen for superior insulation, chemical inertness and fire resistance. However, the soft, unprotected, thick-wall Teflon was susceptible to creep, cold-flow deformation and abrasion. Teflon coating wore away during installation and training. Exposed electrical wiring cracked and contributed to unending command module technical problems during tests. Five days before the fire, a frustrated Grissom hung a lemon from his yard on the simulator.*

- **HSF-1 examples:**
  - *Apollo-1: Given the fragile nature of the Teflon coated wiring, inadequate attention was given to the inspection of the wire bundles to detect abrasion or deformation.*

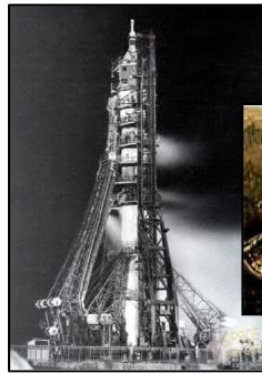
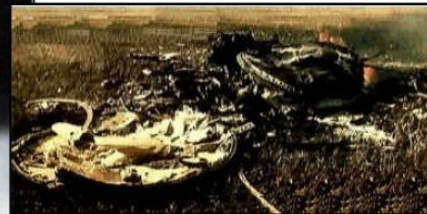
### Soyuz-1 Main and Reserve Parachute Failures During Reentry

April 24, 1967  
Loss of Flight Crew (1)

- *Soyuz-1: The failure mode of the primary parachute's malfunction (jammed in its container), which caused backup chute failure as well, was not accounted for in the design.*

- *Soyuz-1: There was no requirement to inspect the parachute container for contamination.*
  - *Skylab-1: There was no system feedback (such as a visual cue) to the technicians, quality inspectors, and engineers that a “tight fit” had not been achieved during rigging. Inadequate quality inspections.*

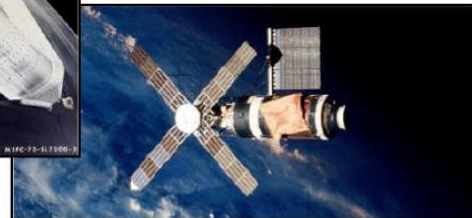
### Skylab-1 Loss of Meteoroid Shield During Launch Ascent

May 14, 1973  
Rescue Mission Needed to Save the  
Orbital Workshop

- *Skylab-1: "Despite six years of progressive reviews and certifications, two major hazards eluded discovery until actual flight: aerodynamic load effects on the meteoroid shield and aeroelastic interactions between the shield and its external pressure environment during launch escaped otherwise rigorous design, research and test engineers working under experienced and competent leadership."*

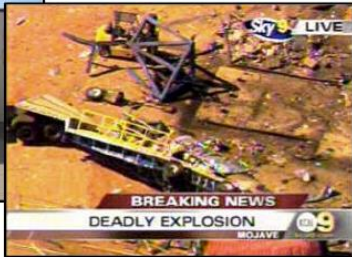
**Scaled Composites Ground Explosion During Cold Flow N2O Test**  
 July 26, 2007  
 Loss of Ground Crew (3) and Ground Crew Injuries (3)

- **Scaled Composites:** Multiple OSHA citations were issued before the mishap regarding lack of engineering controls to abate well-documented N2O storage and handling hazards.

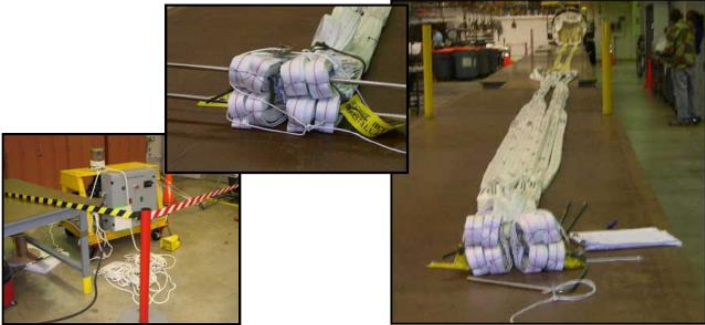
**Ares-1X Steel Rod Mishap During Static Strip Test at KSC Parachute Refurbishment Facility**  
 September 5, 2007  
 Ground Crew Injury (1)

- *Ares-1X: Even though the parachute riser lines were approximately 4 times longer than the riser lines on the Shuttle's drag chute, there was no requirement for engineering to perform a first-time GSE DE loads analysis of the test set-up or a readiness review for the initial Area-1X parachute static strip test.*

- *Ares-1X: The initial Ares I-X strip test set-up combined components (forklift, a capstan winch, nylon break ties, and a nylon towline) in an untested combination. The nylon towline used to extract the parachute released a dangerous amount of stored energy upon failure.*

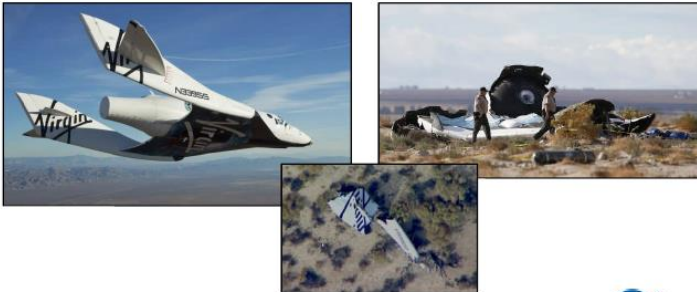
**SpaceShipTwo Test Flight Mishap**  
 October 31, 2014  
 Loss of Flight Crew (1), Flight Crew Injury (1), and Loss of Spacecraft

- 17% of occurrences were related to inadequate FMEA/fault tree analysis
- **HSF-1 examples:**
  - *SpaceShip2: Scaled Composites' System Safety Analysis (SSA) process was inadequate because it resulted in an analysis that failed to (1) identify that a single human error could lead to unintended feather operation during the boost phase and (2) consider the need to more rigorously verify and validate the effectiveness of the planned mitigation measures. (NTSB Finding #6)*

- **SpaceShip2:** The pressure to approve experimental permit applications within a 120-day review period...interfered with the FAA's ability to thoroughly evaluate the SS2 experimental permit application.

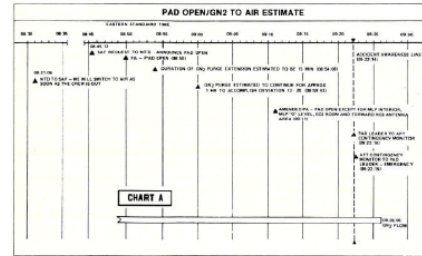
- **STS-1:** The shop schedule was followed instead of the integrated schedule. The shop schedule showed the deviation as being hazardous, but the integrated schedule did not. Schedule motivation created a practice of allowing side work to be approved and carried out in parallel with hazardous operations which increased risk and susceptibility to an accident. Scheduling of side work during hazardous operations should be prohibited as a matter of practice. Where exceptions must be made, they should be placed under stringent firing room and/or safety controls, and coordinated with all involved parties.

STS-1 mishap report timeline of GN2 purge continuing after pad was re-opened for work

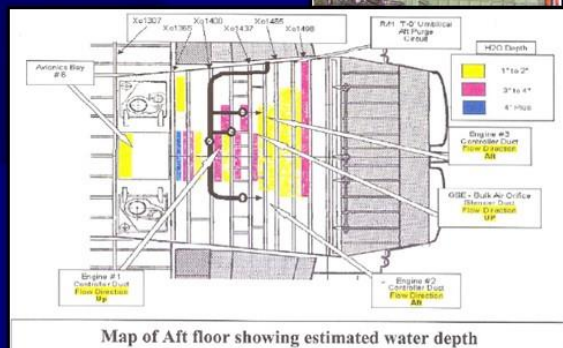
Shuttle Mini Portable Purge Unit (MPPU)

Map of Aft floor showing estimated water depth

In the MPPU refurbishment design plan, include sensors to monitor moisture/humidity extraction levels and to automatically warn the operator(s) if an anomaly occurs. Note: a redundant drain path does not address the risk of a common cause failure.

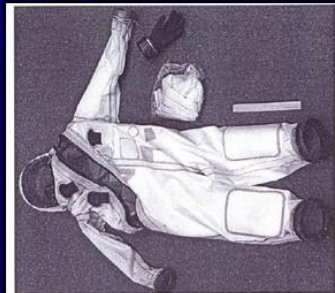
Figure 1

### SCAPE Suit Oxidizer leak (06/26/03)

As-received PHE, left hand glove, and undershirt in bag.

Impose strict limits on the number of suit repairs and/or implement a used suit validation/certification procedure. For example, pull suit off-line every ten patches to recertify the suit.

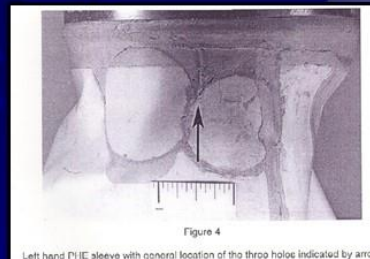
Figure 4

Left hand PHE sleeve with general location of the three holes indicated by arrow
