Common Applications for Acoustic Emission Testing (AET)

STEVEN A. GARCIA

SONUS CONSULTING LLC

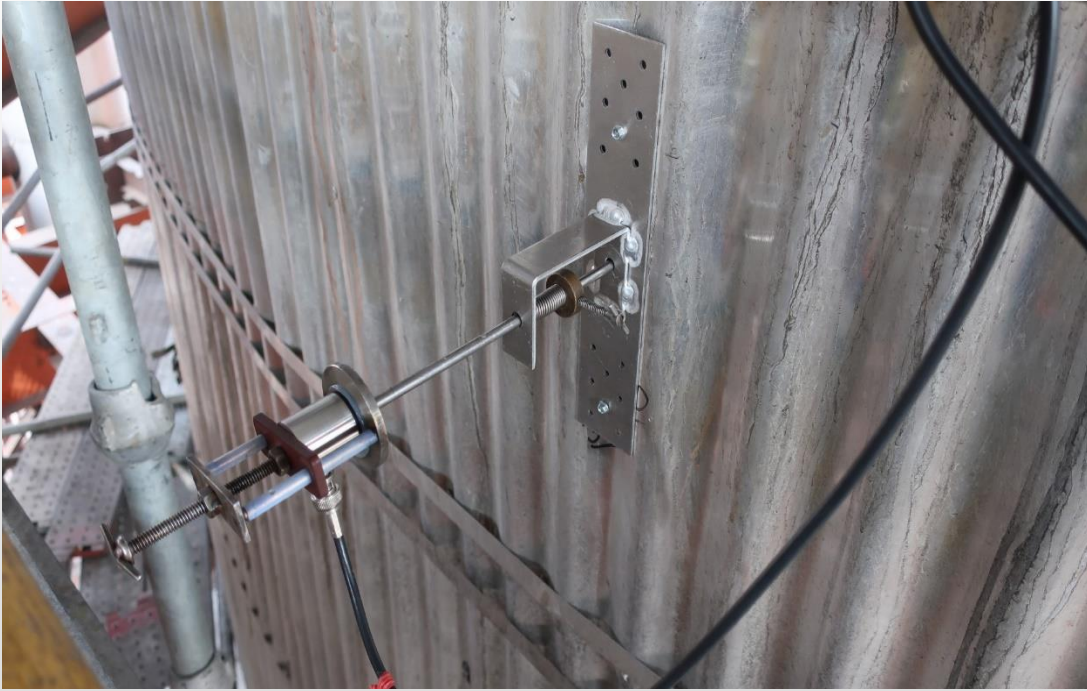
Waveguide

Typical Sensor Mounting Scenarios

AE Technology – What are Waveguides? Why use them?

Allow operators to couple the sensors to high or low temperature materials without damaging the sensor

Waveguides are typically 12-14" long unless the structure is exceptionally hot or covered by thick insulation

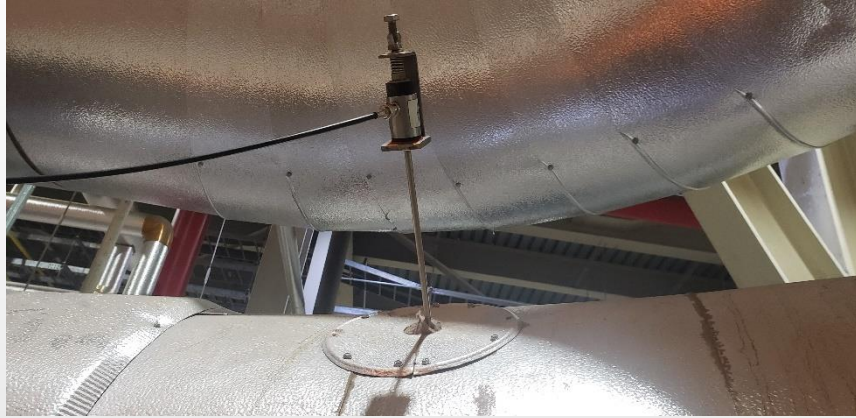
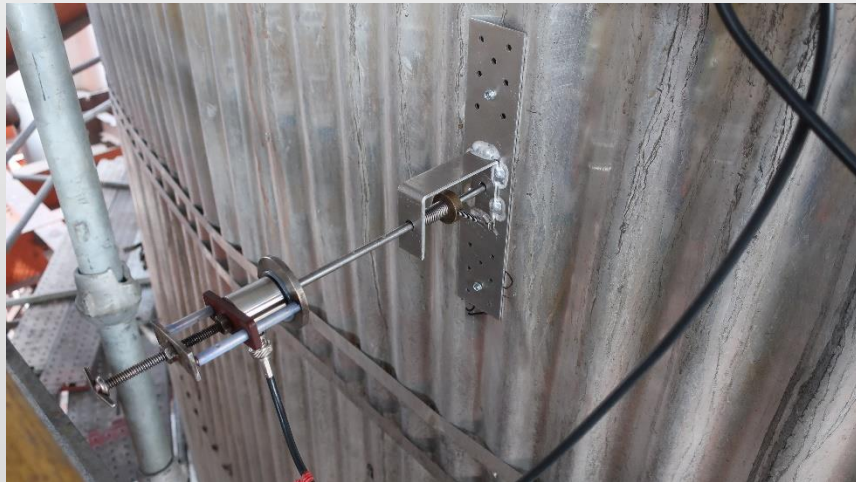
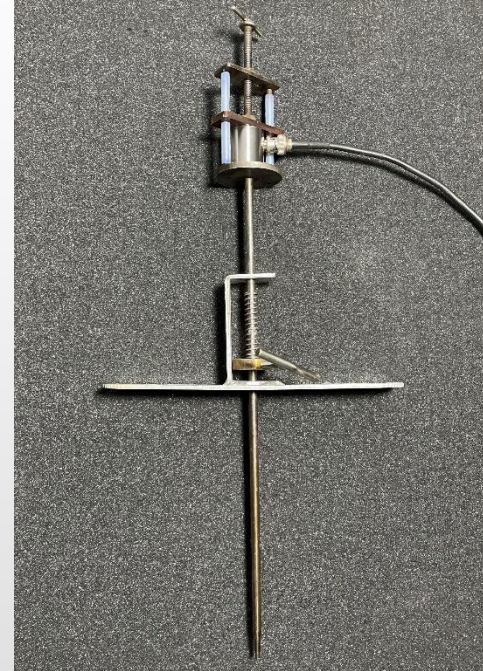
Temperature > 200 °F

1/4" Hole in lagging

1/4" Hole in insulation

Attach to lagging

Adjust collar against spring

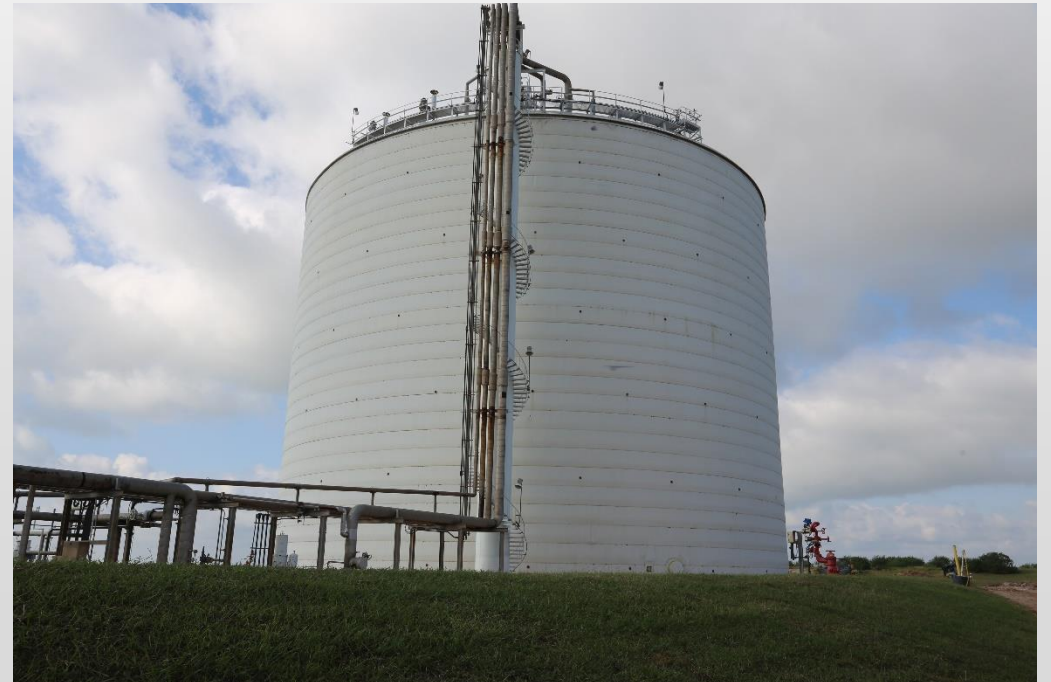
Ammonia Tank AE setup

- 126 AE sensors installed by AE crew using JLG manlifts. UT Survey performed at same time as sensor installation.
- Monitoring took place during filling operation from barges at dock.
- Utilized existing inspection ports used for UT measurements to minimize insulation disturbance.
- Methanol/Alcohol used to mitigate ice formation during sensor installation.
