ISS Inspection Capabilities and Challenges

NASA Johnson Space Center
Astromaterials Research and Exploration Science (ARES)
Image Science and Analysis Group (ISAG)
KX/Randy Moore
<http://isag.jsc.nasa.gov/>

July 2014

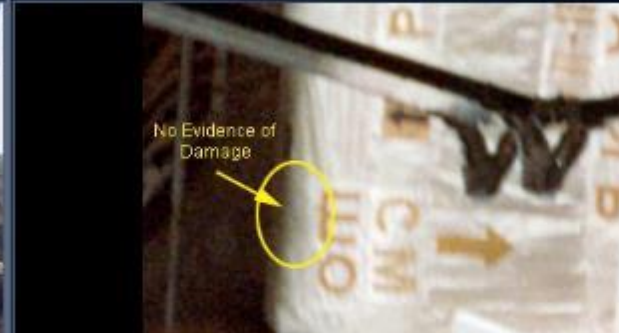
STS-114 Fly-Around Imagery - FGB Zenith Side (cropped, enhanced)

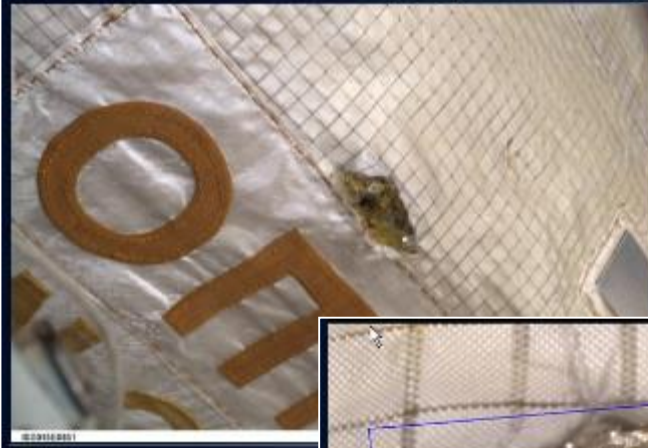
Expedition 15 EVA 18 - FGB MMOD Strike (Image ID: ISS015E10851)

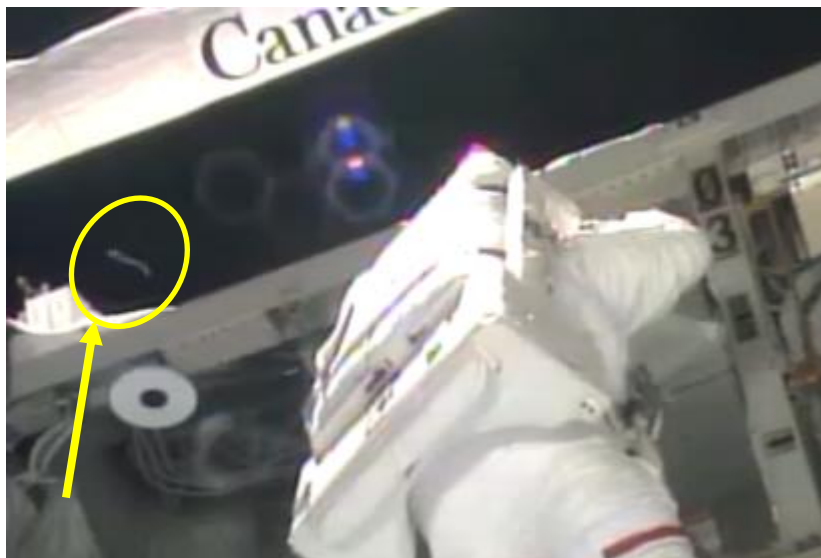
Foreign Object Debris detected in pre-berthing survey

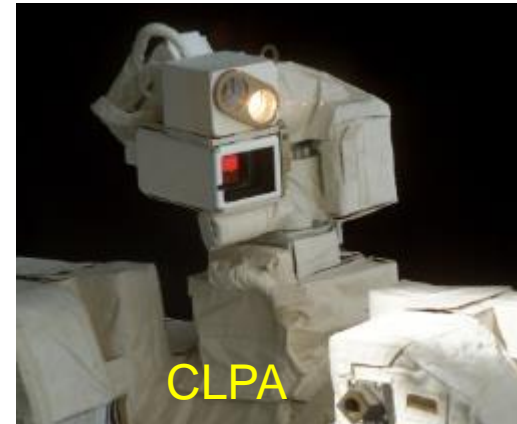
External Television Cameras (Mobile Servicing System)

- Both CLA and CLPA utilize the same CCD camera and lights
- FOV Max ~ 52° x 40°, ~9mm focal length,
Min ~ 6°x4° , ~84mm focal length
- Zoom ratio ~9:1
- The minimum viewing distance is 14 in.
- MSS camera “detectable” resolution at max zoom is approximately
 - ~.2 inch at 25 feet
 - ~.4 inch at 50 feet.
- Standard ETVCG and MSS frame rate: 30 fps

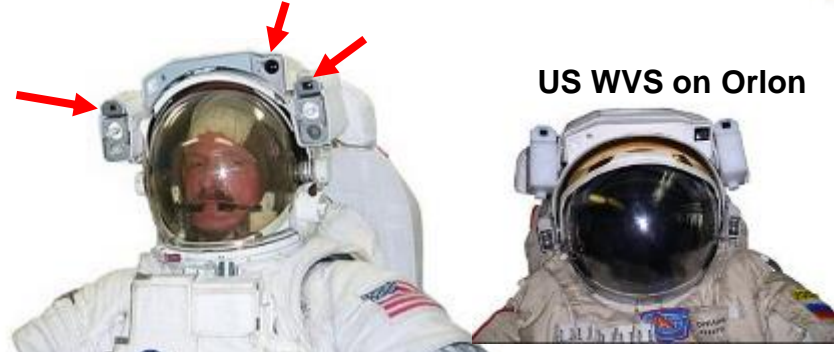
Wireless Video System

- Three SONY XC-999 cameras
- HFOV = 85°, 56° and 30°
- Fixed depth of focus 12 inches to 25 feet.
- Detectable resolution .25-.5 inch at 10 feet.

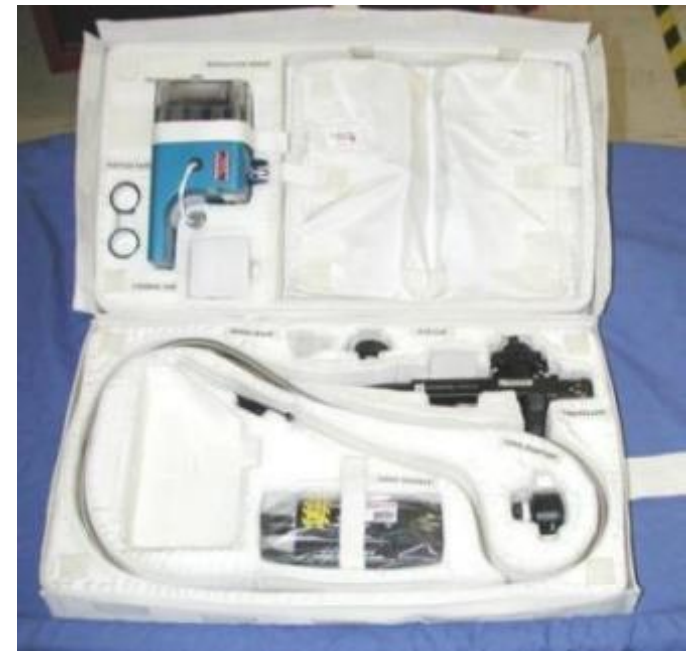
Sony XC-999 Mini-cam
Video camera with fiberscope

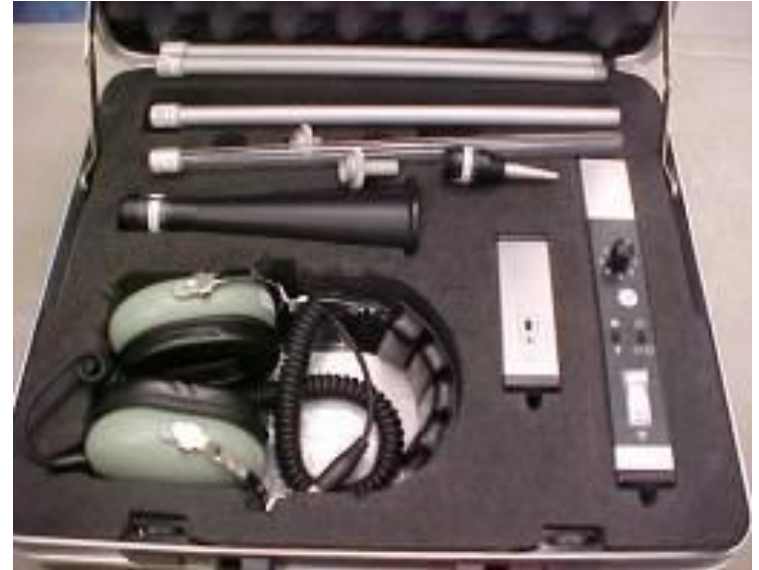
- Handheld Ultrasonic leak detector
- Ammonia Mass spectrometer
